Technical Bulletin

Installation recommendations for timing system on GM 1.4, 1.6, 1.8, 2.0, 2.2 16V engines

GATES REFERENCE :	5368XS, 5369XS, 5408XS, 5461XS, 5499XS, 5542XS
MAKE :	OPEL / VAUXHALL
MODEL :	Astra, Calibra, Combo, Corsa, Cavalier, Frontera, Kadett, Meriva, Omega, Signum, Sintra, Tigra, Vectra, Zafira
MOTOR :	1.4, 1.6, 1.8, 2.0, 2.2 16V
MOTOR CODE :	C14SEL, X14XE, C16SEL, C16XE, X16XE, X16XEL, Y16XE, Z16XE, C18XE, X18XE, X18XEL, Z18XE, Z18XEL, X20XEV, X22SE, X22XE, Y22SE, Y22XE, Z22XE

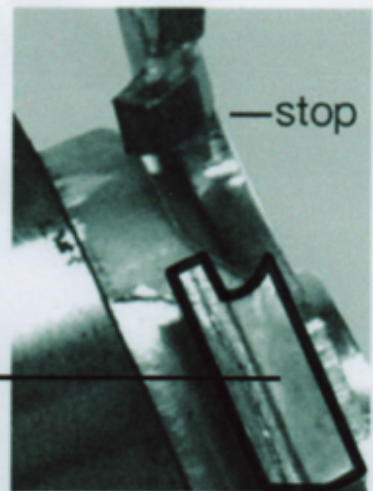
Fig. 4

Rotating the tensioner in the wrong direction, having the Allen keyhole in a wrong position to start off, not turning the engine 2 revolutions before and after setting the tension, can lead to system failure. This will cause the arm of the tensioner to hit the stop, creating a hammering noise, damaging and possibly even rupturing that part. This failure mode is very common and can easily be recognised when inspecting the edge of the arm (fig. 4). The resulting wrong tension can cause the belt to rupture.

"damaged"
